DELAWARE RIVER BASIN
HAYNES CREEK TRIBUTARY
BURLINGTON COUNTY
NEW JERSEY

MISHE - MOKWA DAM
NJ 00419

PHASE 1 INSPECTION REPORT
NATIONAL DAM SAFETY PROGRAM

May 79 1979

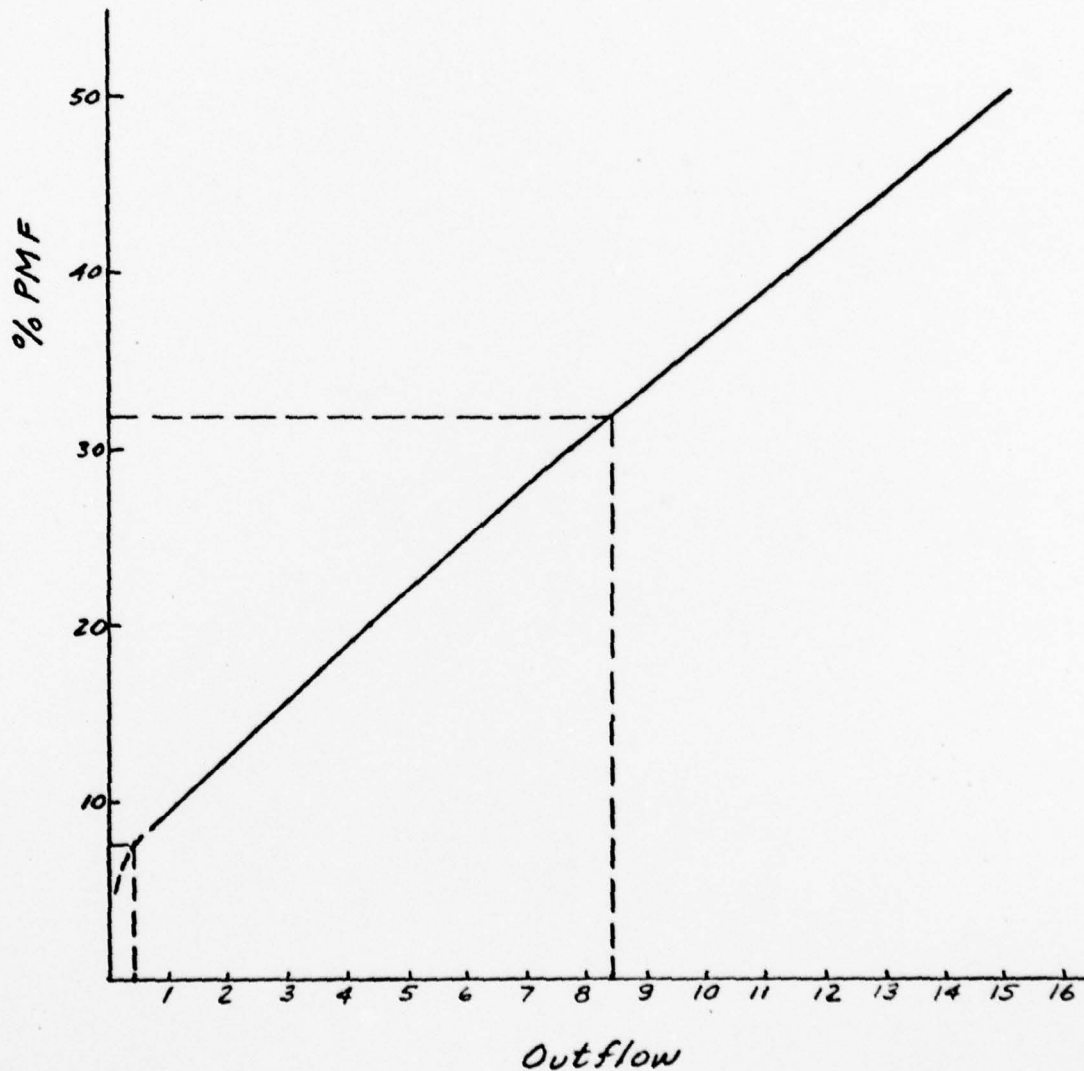
OVERTOPPING POTENTIAL

Overtopping of low area occurs at elev. 71.2
with $Q = 42$ c.f.s. ($\sim 8\%$ PMF)

Overtopping of dam occurs at elev. 72.4 with
 $Q = 844$ c.f.s. ($\sim 32\%$ PMF)

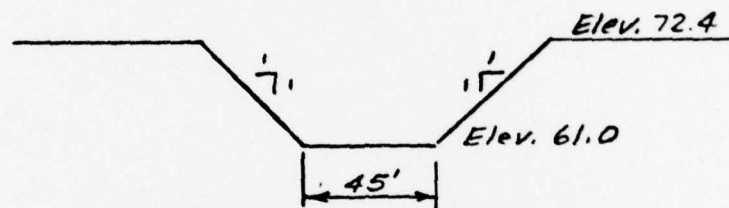
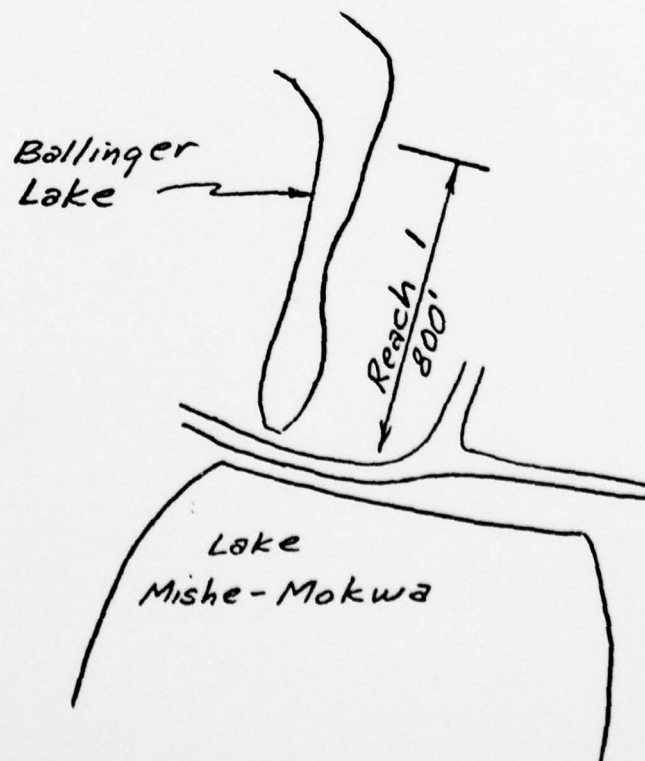
BREACH ANALYSIS

Assume breach begins to develop when
reservoir stage reaches elev. 72.4 (top of dam).
Time to fully develop = 1.0 hr.
